Case 250 : Narrative

Case Vehicle (A): 2000 Ford
Type: Ranger XL, 4 x 4, 4-door pickup
Driver: 16-year-old male
CDC: 11-FLEE-3

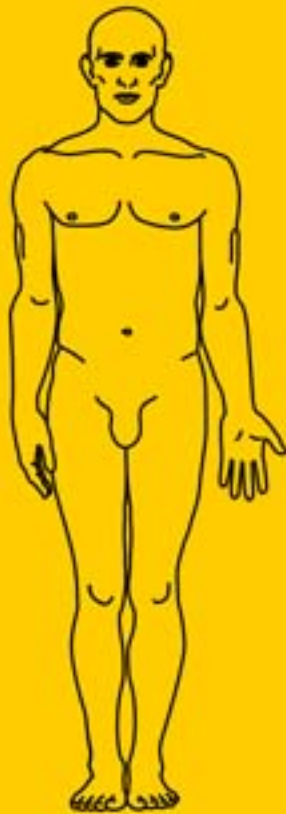
Cervical
strain
(1)

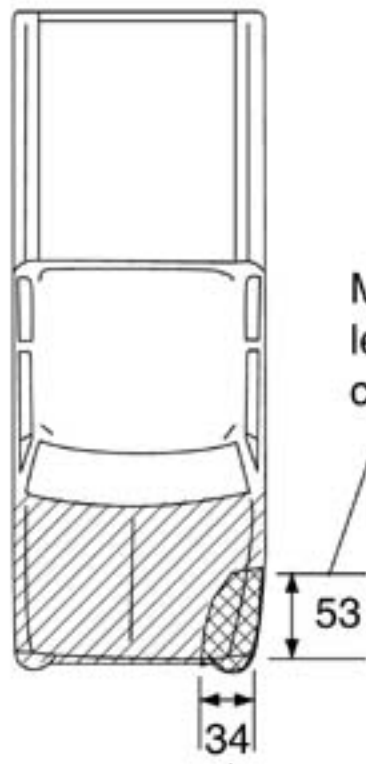
Max. crush to left-front bumper corner

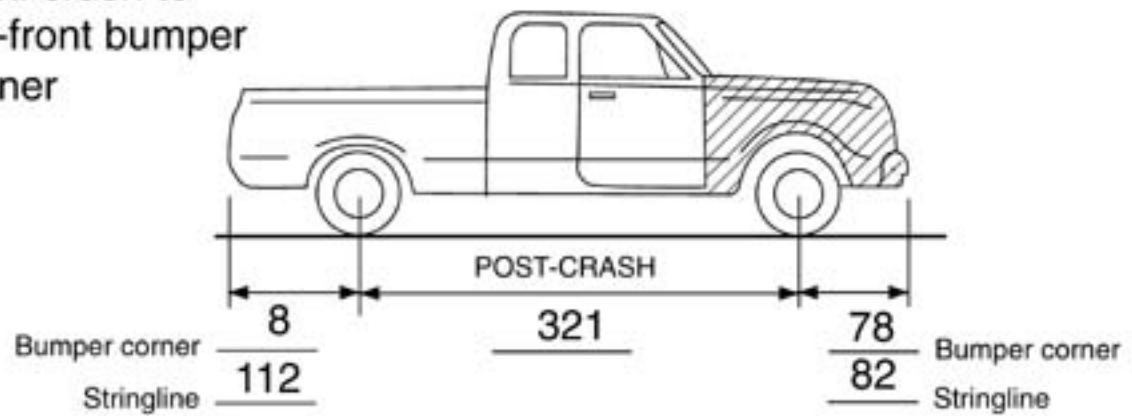
Width of direct damage to front

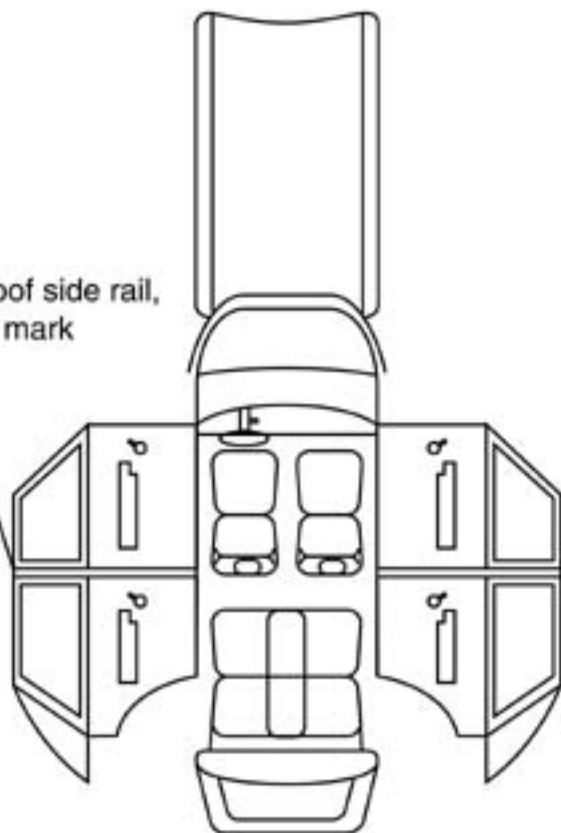
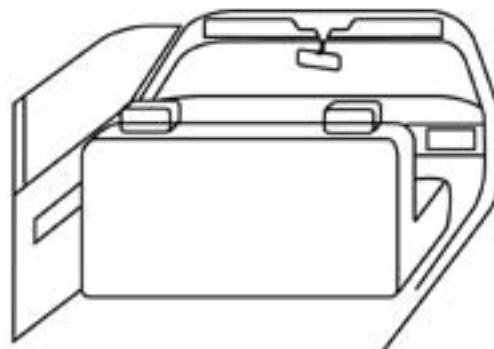
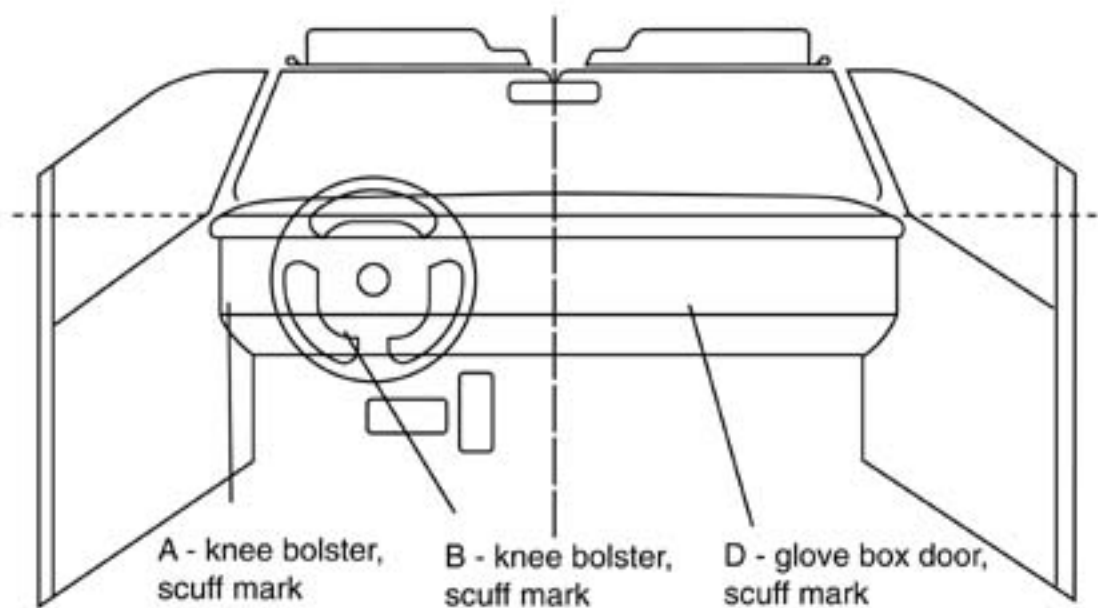
C - roof side rail,
scuff mark

A - knee bolster,
scuff mark

B - knee bolster,
scuff mark
